COMPARISON OF DIFFERENT SPACE INDEXING METHODS FOR ECOLOGICAL EVALUATION OF URBAN OPEN SPACES

TAKÁCS, D.* – VARRÓ, D. K. – BAKAY, E.

*Corvinus University of Budapest, Department of Garden and Open Space Design
1118 Budapest, Villányi út 29–43., Hungary
(phone: +36-1-482-6290)*

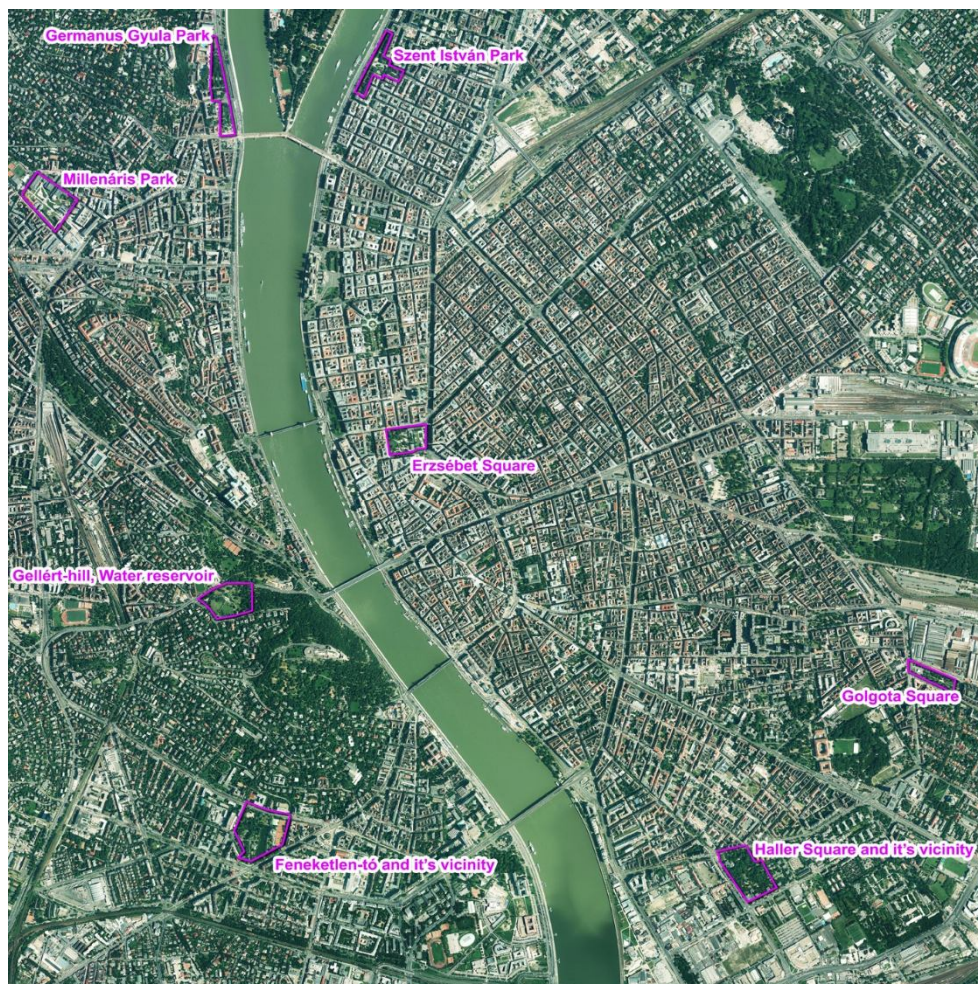
Figure 1. Location of analyzed and reference parks on the orthophoto of Budapest (2010)

All of the researched areas are in Budapest, the capital city of Hungary. Their sizes vary from 2-3 to 6-8 acres. Four of the sites (Millenáris Park, Gellért Hill water reservoir, Germanus Gyula Park and Lake Feneketlen) are located in Buda, the other four (Erzsébet Square, Golgota Square, Haller Park and Szent István Park) are on the Pest side of the Danube river (*Fig. 1.*).

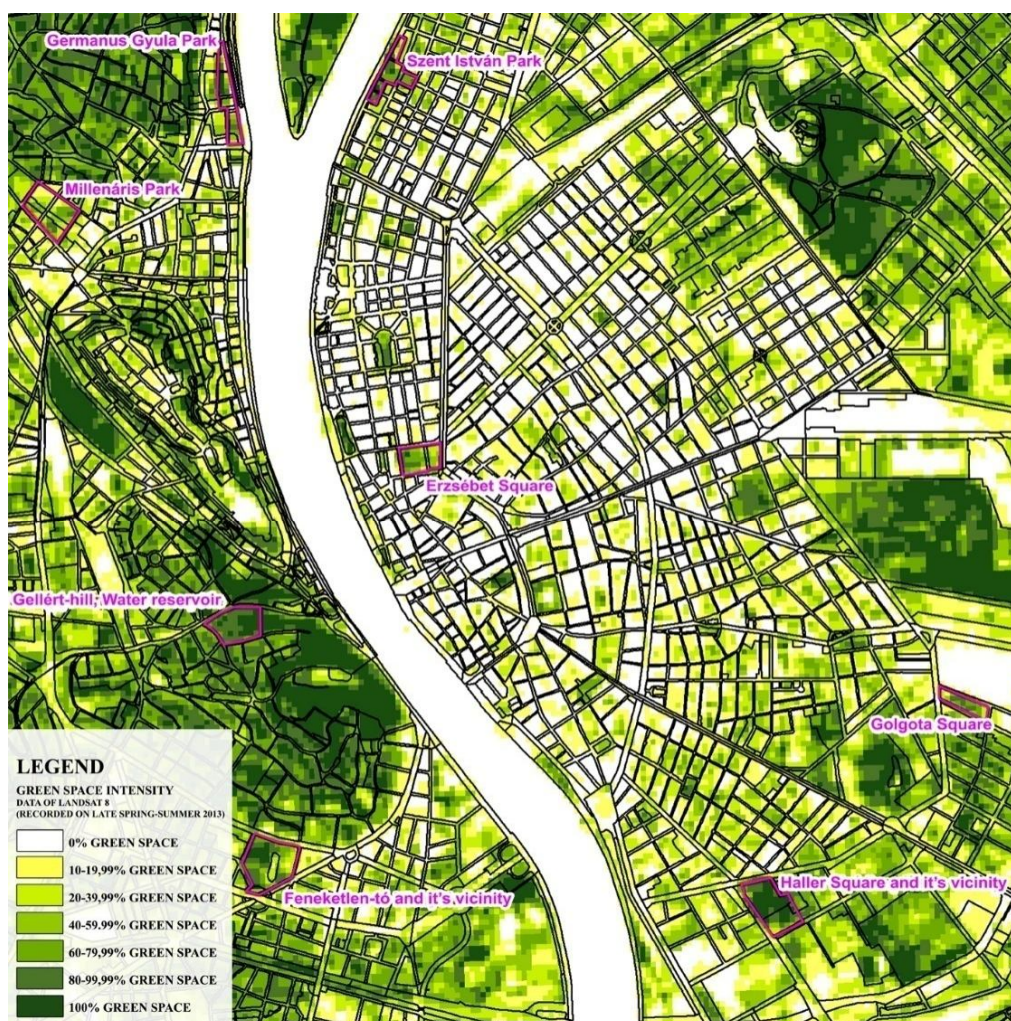
Figure 2. Intensity of green surface in Budapest (late spring-summer 2013)

The GSI maps we used during the research are fitted onto vector graphic surveys. The plot boundaries of each area are also represented on these vector graphic maps and they could be clearly observed on the Fig. 2. as well. We made the BA analyzes inside these boundaries and created the site maps by using the same vector graphic system.

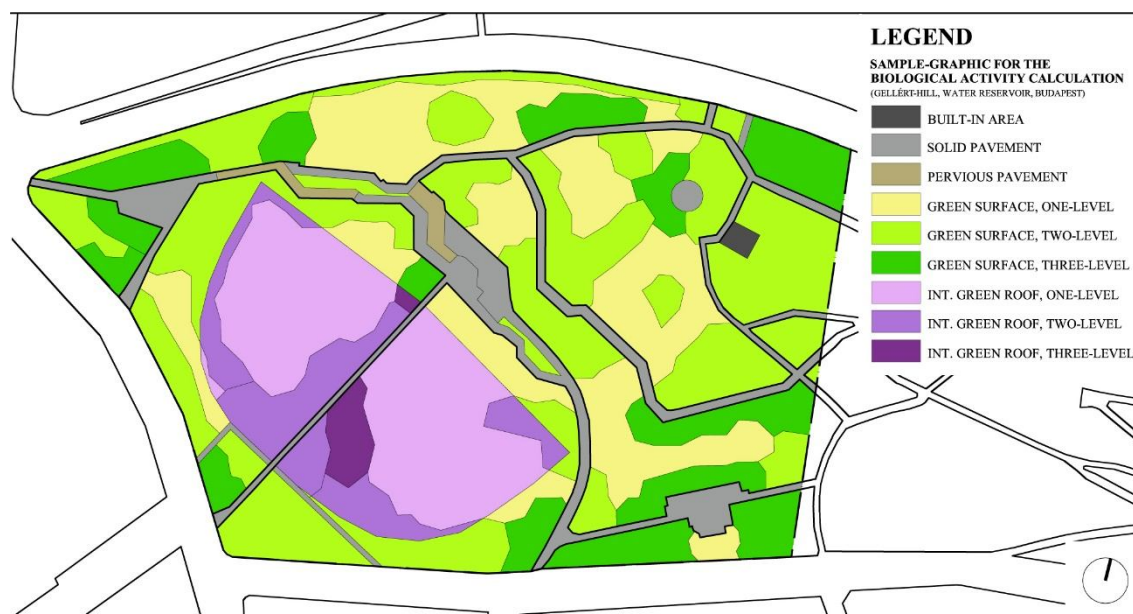
Figure 3. Site map for biological activity calculation (water reservoir on Gellért Hill, Budapest)

at that time, the need for potable water grew tremendously, which could be fulfilled only by building a new water reservoir. From technical point it had an ideal location at the top of Gellért Hill. On the other hand it is visually an extremely sensitive location in the city, and a great tourist attraction with a fantastic view. As a compromise an underground water reservoir was built, very unusual at that time with a public park on the top of it. The soil cover above the tanks (each 40 000 m³) varies between 0,6 to 1 m. Unique retaining wall system made of concrete, reminiscent of old fortification and steep slopes span the elevation difference. In the eastern part of the site, where no big scale earth work was done, some old honey-locust (*Robinia sp.*) trees from the time before the construction can be still found. Most of the woody vegetation was planted at the time of the construction and the plants are located to strengthen the grading concept, so more or less along contour lines (Fig. 3.).

Large part of the area is covered by vegetation. The paved walkways take up about 12% of the total area which is one of the lowest percentages among our sample areas. It is important to be mentioned, that green surfaces above the water tanks must be classified in the green roof categories, therefore their BAR values are lower than the other green surfaces (Table 5.).

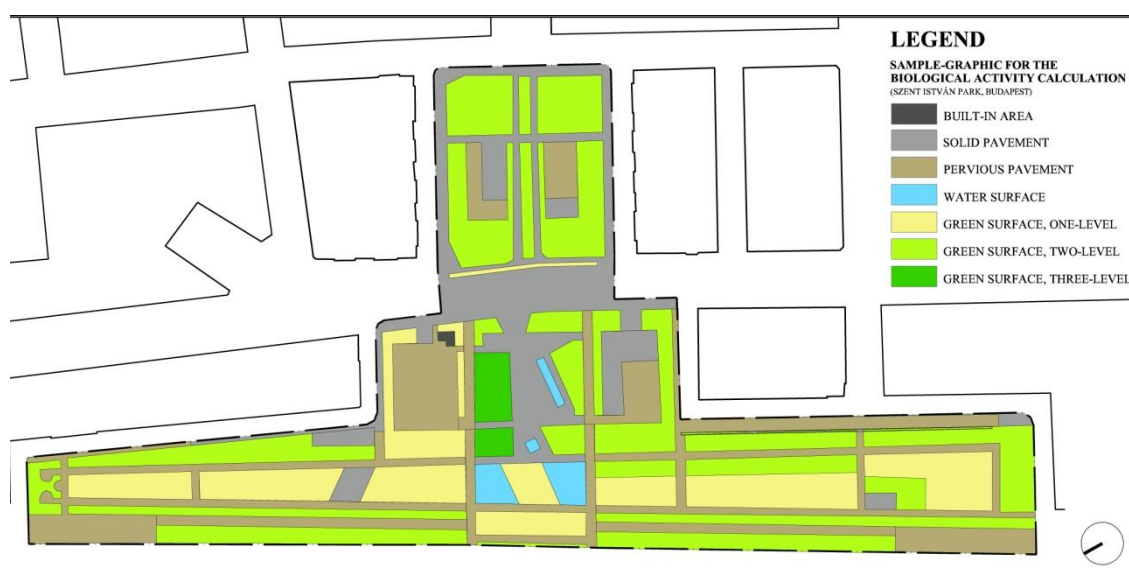
Figure 4. Site map for biological activity calculation of Szent István Park, Budapest

Beside the low amount of built-up areas, large scale (approx. 73%) of the paved surfaces are pervious pavement, only the pedestrian, the traffic areas and the sport field have solid (e.g. asphalt and stone) pavements. The green surfaces are covered mostly by two-level vegetation, only a small part of the area near the paved leisure surface in the middle has three-level structure with approx. 600 m². (Fig. 4., Table 10.)

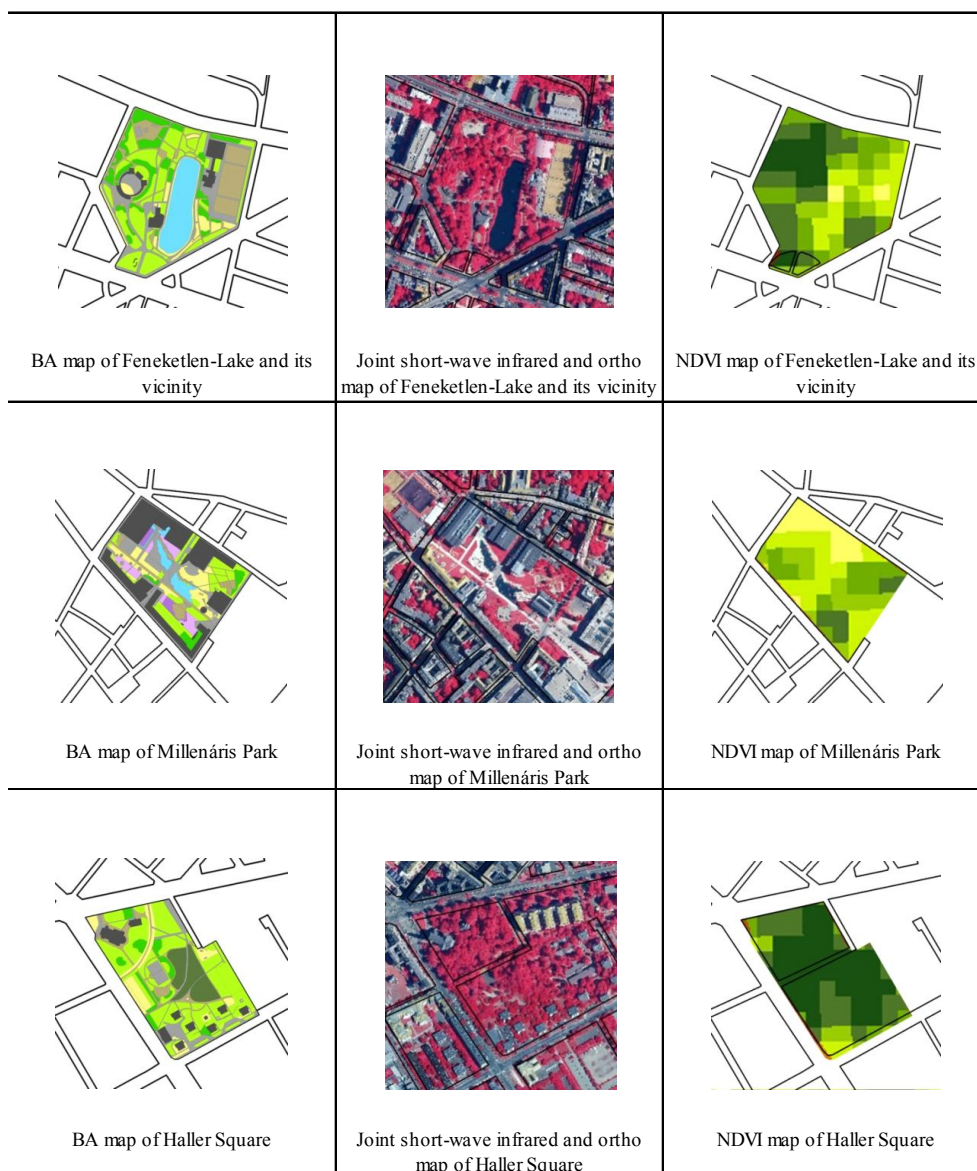
Figure 5. Comparison of Biological Activity, short-wave infrared and NDVI maps

of the BA rates of each surface of the area. (GSI index is a ratio, while TBAR index is just a value depending on the size of the analyzed surface.) A new index had to be introduced in order to make the GSI and TBAR values comparable. This is Maximum Biological Activity Rate (MBAR) which shows the activity rate that can be reached in the case of maximum (100%) GSI. We supposed that the maximum GSI can be reached in case of three-level vegetation which situation also corresponds with the maximum TBAR affordable on these urban located areas. The analysis and comparison of the graphic maps, based on site visits and the satellite pictures (taken by the Landsat 8 satellite) verified our supposal (*Fig. 5.*).

Where the pixels on the NDVI pictures are dark green, the vegetation structure is mostly two- or three-level on each plot. Therefore it is proposed to determine the

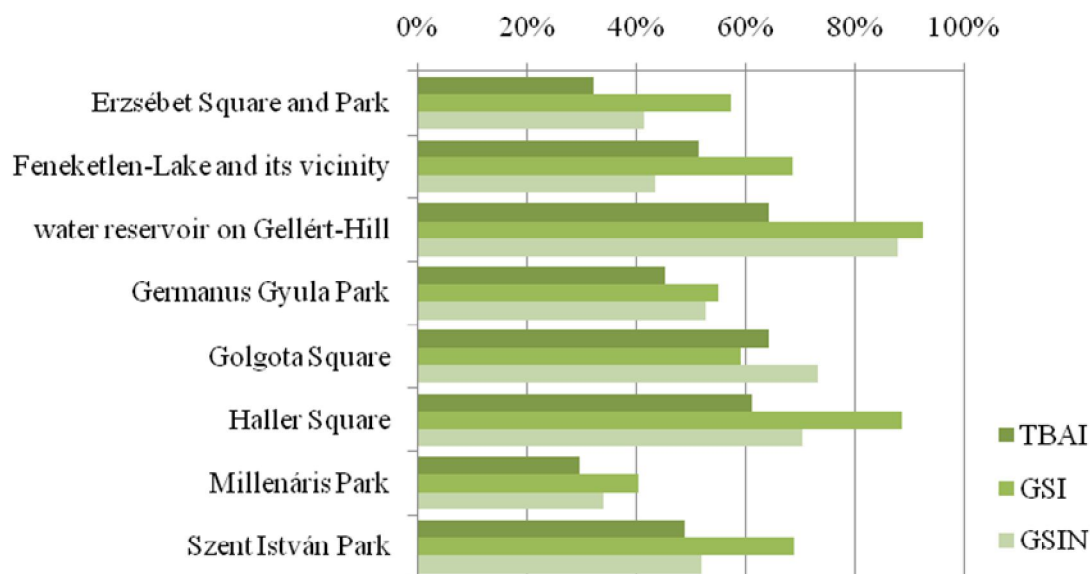
Figure 6. Summary diagram of TBAI, GSI and GSIN rates

As it can be noticed from the summary diagram, there are significant differences between the TBAI and GSI values in cases, like at water reservoir on Gellért Hill (*Fig. 6.*). The main reason of it is particularly the difference between the evaluation processes. Based on the comparison of data in the summarizing table we can make certain statements regarding the different evaluation methods.

The calculations of the two methods using different evaluation processes and the rates associated to them as reference points gave similar results regarding the hierarchy (position) of the analyzed plots.

The water reservoir on Gellért Hill is a significant area, which reached the best rank (R = 1) according to all three methods. The reason of this is obvious just by looking at the survey map: This area has the lowest built-up and paved surface-rate (11,98%). The Millenáris Park reached the worst rank (R = 8) according to every aspects. The reason

In the case of Golgota Square, the TBAI (64,26%) is much higher than the GSI (59,20%). A reason could be that the structure of the vegetation is more significant for the BA calculation, then its condition. In contrast to this, in the case of GSI rate the condition of vegetation is concluded from the chlorophyll amount. Another reason of the difference comes from the resolution of the satellite photos. The photos which are available for us, are not detailed enough to get exact view of the GSI data of each areas. This is true especially in the case of long and narrow sites, where 80-90% of a pixel is on the edge of the inner and outer part of the area. In this case the chlorophyll index of the pixel is determined by rate of the inner and outer areas' chlorophyll indices like on Golgota Square.

The GSI (92,55%) and GSIN (88,02%) values of the water reservoir on Gellért Hill are very close to the 100% and to each other. In contrast to this, the TBAI (64,38%) is pretty low, which could be explained by the high green-roof rate (22,49%). These green surfaces cannot participate in to the water circulation of the natural areas in the city; therefore they have lower BAR value, than the green surfaces on the ground.

We have to highlight the Lake Feneketlen and its vicinity, because only this is the only site having higher TBAI (51,51%) than GSIN (43,55%). The reason is, that the site has a huge water surface (approx. 9800 m² – 12,77%) in the middle, which is noted with very high BAR/acre value (6) during the calculations. This case is a good example for showing the defect of the BA calculation process: The formula gives a BAR/acre value for water surfaces, but does not deal with the way these elements were created, whether they are natural lakes or just ornamental pools, which make a huge difference in urban ecology.
